# Existing Conditions Presentation

Existing Bridges Subcommittee  
Hinsdale Police Station  
10 Main Street, Hinsdale, NH  
May 23, 2019

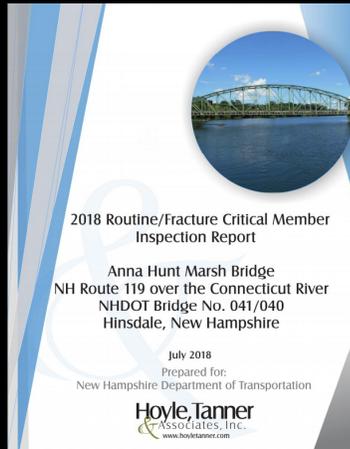
# Anna Hunt Marsh Bridge (041/040)

- Added as red list bridge in 2018
- Year built, rehabbed: 1920/1988
- Road width = 20' feet, 4 inches
- Length = 339 feet
- Height limit = 11.55 feet
- Deck = Good
- Superstructure = Poor
- Substructure = Satisfactory
- Scour rating = Stable
- Federal Sufficiency Rating = 27.8

- The bridge is comprised of two (2) Camelback through steel trusses spaced at 23'-0" and has a span length of 330'-0". Truss members consist of riveted built-up chords, verticals, diagonals and horizontals. The floor system consists of variable thickness precast concrete deck panels supported by eight end panel and intermediate panel stringer lines and floorbeams at interior panel points. The bridge deck supports a 20'-4 1/8" roadway. The bridge also supports a 5'-3" cantilevered sidewalk with a timber deck.

- Bridge deck was replaced in 2004 and the floor system (stringers and floorbeams) was replaced in their entirety in 1988.
- The bridge rail was replaced with double nested Wbeam guardrail in 1988.

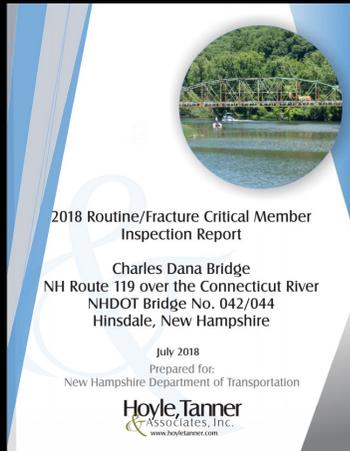
# Charles Dana Bridge (042/044)

- Added as red list bridge in 2018
- Year built, rehabbed: 1920/1988
- E-2 Bridge
- Road width = 20' feet, 4 inches
- Length = 297 feet
- Height limit = 12.14 feet
- Deck = Good
- Superstructure = Poor
- Substructure = Fair
- Scour Rating = 7 Countermeasures
- Federal Sufficiency Rating = 37

- The bridge is comprised of two (2) Camelback through steel trusses spaced at 22'-8" and has a span length of 200'-0". Truss members consist of riveted built-up chords, verticals, diagonals and horizontals. The floor system consists of variable thickness precast concrete deck panels supported by eight (8) stringer lines and floorbeams at interior panel points. The bridge deck supports a 20'-4 1/8" roadway. A cantilevered sidewalk with a timber deck was added to the bridge in 1994.

- The bridge deck was replaced in 2004 and the floor system (stringers and floorbeams) was replaced in their entirety in 1988. The bridge rail was replaced with double nested Wbeam guardrail in 1988. A cantilevered sidewalk was added to the northerly truss in 1994.

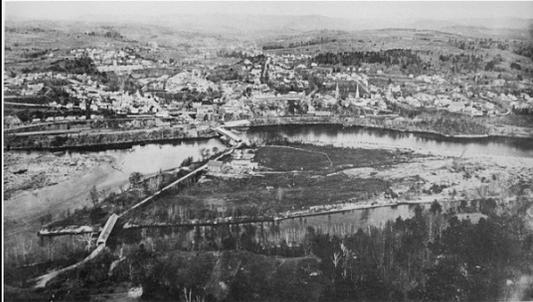
Figure 1. View of Hinsdale Island toward Brattleboro, Vermont (1879). Source: Brattleboro Historical Society.

- Hinsdale Island was much larger before Vernon Dam.
- First bridged in 1803.
- Vernon Dam constructed in 1909.
- Parts of Hinsdale Island inundated were completely eroded in 1936.

- Hinsdale Island was once much larger in size, as compared to today.
- When first bridged in 1803, the island was rich farmland.
- The sections of the island that were inundated by the construction of Vernon Dam (all of which does not currently remain) was completely eroded away by 1936.
- Vernon Dam was constructed in 1909.

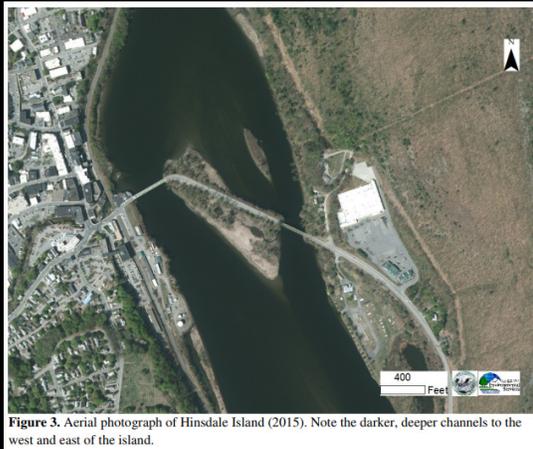
Figure 3. Aerial photograph of Hinsdale Island (2015). Note the darker, deeper channels to the west and east of the island.

- After Vernon Dam, inundated the lower elevation areas, particularly northern side
- Hinsdale Island mostly alluvium (river deposited sediment)
- Route 119 road bed is only fill on island

- After its construction, the Vernon Dam elevated the water level in the river so that it inundated the lower elevation areas of the island, particularly on its northern side.
- Hinsdale Island was mapped for its surficial geology, through the Surficial Geologic Mapping Program in 2000, and was found to consist of alluvium (river deposited sediment), except for the existing Route 119 roadbed, which is comprised of fill.
- The Route 119 road bed is the only location that was found to be mapped as fill on the existing island.
- Aside from the Route 119 fill, elevations of the terrain on significant portions of the island are only 2 to 3 feet higher than the normal water surface elevation of the Connecticut River (LiDAR imagery, Figure 6).

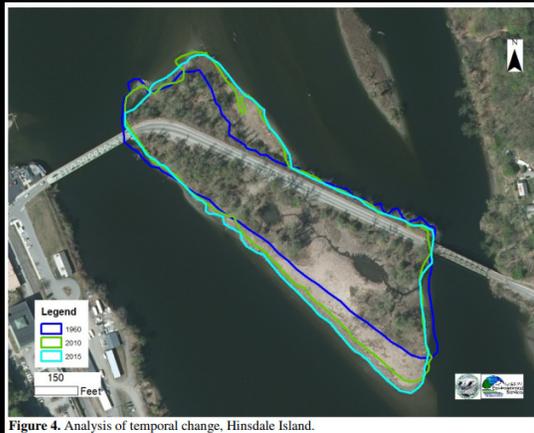
- Hinsdale Island's boundaries shown in 1960, 2010 and 2015.
- From 1960 to present, it has maintained its basic form and location.
- However the island has grown in size.

- Three aerial photographs were used by NHGS to evaluate the change in island planform temporally: 1960, 2010, and 2015.
- Overall, from 1960 to the present, Hinsdale Island has maintained its basic form and location.
- However, as can be seen in the comparison of the island boundaries through time, the island has, overall, grown in size.
- In 1960, the size of the island, based on the digitized boundaries, is approximately 378,000 ft<sup>2</sup>.
- The size increased to 440,000 ft<sup>2</sup>, and then to 468,000 ft<sup>2</sup> (2010 and 2015, respectively).
- Areas of maximum accretion occurred at the southern tip and the north corner of the island.
- However, an area of erosion, with time, exists at the northwest tip of Hinsdale Island. Here, the island boundary in 2015 is about 75 feet south of its boundary in 1960.

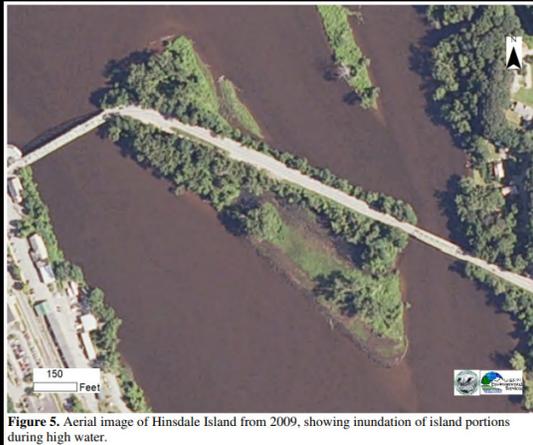
Figure 5. Aerial image of Hinsdale Island from 2009, showing inundation of island portions during high water.

- Island shown during period of inundation in 2009.
- The temporal analysis suggests that Hinsdale Island is largely accreting and not eroding.
- Risk of erosion contingent on a number of factors.

- The temporal analysis alone suggests that Hinsdale Island is largely accreting and not eroding, except for a section at its northwest tip.
- Although this is the result of the requested analysis, the risk of further island erosion beyond what the trends suggest is possible, as a result of the following enumerated factors.

3. The fact that sections of the island do become inundated during higher flows (see Figure 5).
  4. The existence of a small flood chute that branches off of the main Connecticut River flow and onto the island's east side, which could transport high flows and potentially erode.

- While the aerial photograph analysis suggests that the island is accreting material, locations of accretion seemingly correspond with areas most prone to inundation during higher flows (such as in Figure 5).

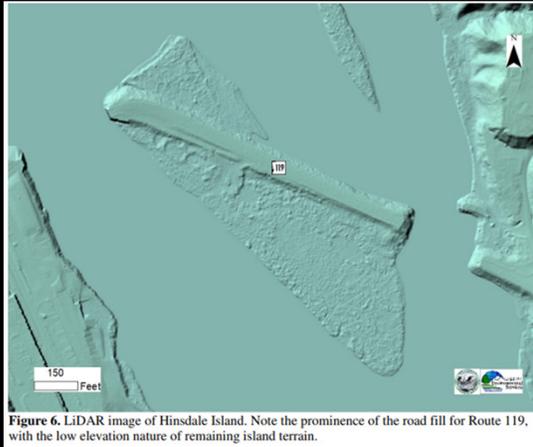
Figure 6. LiDAR image of Hinsdale Island. Note the prominence of the road fill for Route 119, with the low elevation nature of remaining island terrain.

- In its current form, areas of island at reduced risk of erosion are:
  - Deposited sand has been in existence for longer period of time
  - Where there is vegetation to hold the sand in place.
- Further investigation is recommended

5. Aside from the Route 119 fill, elevations of the terrain on significant portions of the island are only 2 to 3 feet higher than the normal water surface elevation of the Connecticut River (LiDAR imagery, Figure 6).

- In its current form, areas of the island that will be at reduced risk for erosion will be those where (1) deposited sand has been in existence for a longer period of time and is more accumulated, and (2) that has increased integrity as a result of vegetation to hold the sand in place.

- It would be recommended that a further investigation of Hinsdale Island be undertaken to evaluate the stability of its sandy surface, and its ability to be eroded, the extent to which vegetation is contributing to stability, and the extent of erosion on the northwest tip. Such a field evaluation will be required before further comments regarding the long-term erodibility potential of the island can be made, and should be conducted by an individual trained in geomorphology or earth surface processes.

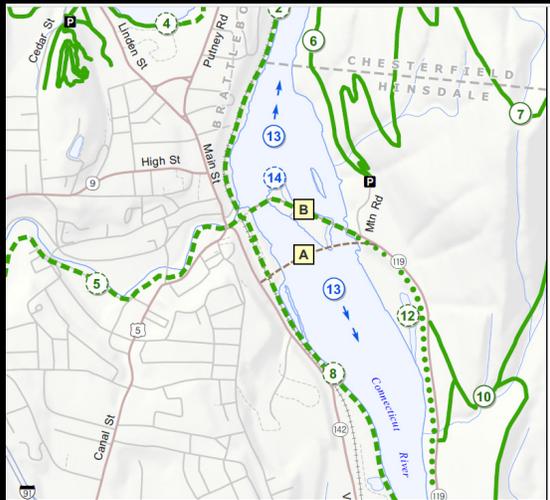
# Trail Connections Map (Handout 1)

**Hinsdale-Brattleboro  
Bridge Project**  
*Trail Connections*

- A** Bridge project
- 1** Existing trails
- 2** Potential connections
- P** Trail parking

This map documents existing and potential walking, biking, and paddling trail opportunities based on various trail stakeholders in Vermont and New Hampshire.

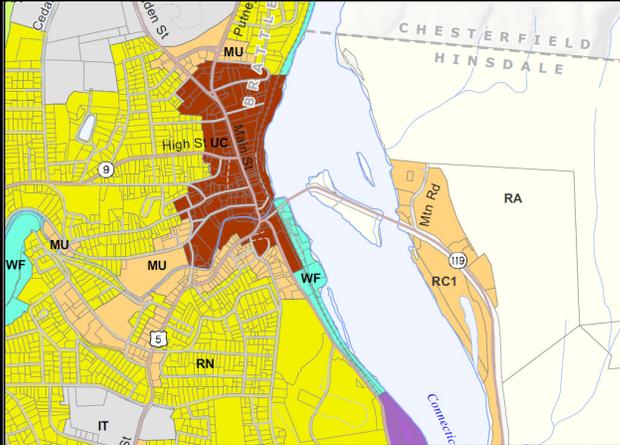
# Zoning (Handout 4)

## Hinsdale-Brattleboro Bridge Project Zoning Districts

- Industrial
- Institutional
- Mixed Use Neighborhood
- Neighborhood Center
- Residential Neighborhood
- Rural Residential
- Urban Center
- Waterfront

- Roadside Commercial District 1
- Rural Agricultural District
